DYNAMIC SCIENCE, INC. In-Depth Accident Investigation

Contract DTNH22-94-A-07049 Case DSI-94-AB-01

TECHNICAL SUMMARY

CONTRACTOR: CONTRACT NUMBER: CASE NUMBER: Dynamic Science, Inc. DTNH22-94-A-07049 Case DSI-94-AB-01

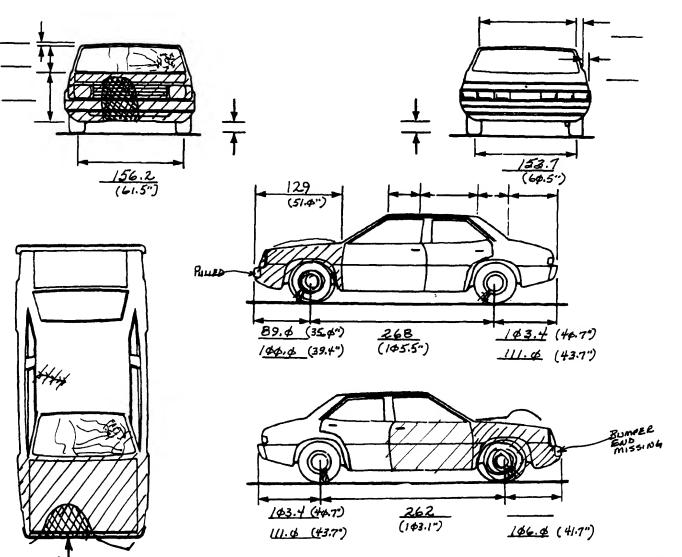
MEASUREMENTS IN CENTIMETERS

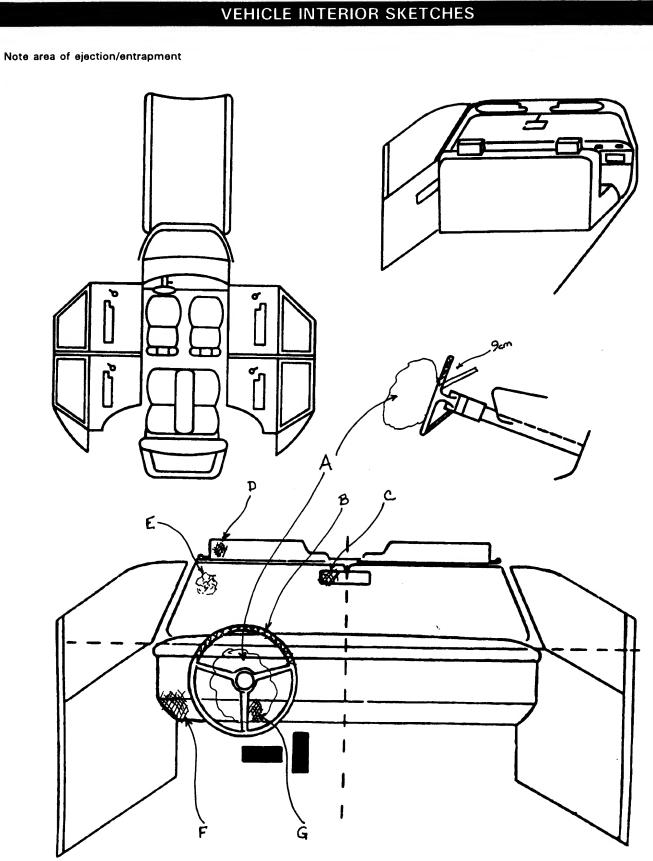
Sketch windshield contact(s) and the damaged area(s) on the instrument panel outline (e.g., radio, glove compartment, damage to instrument panel structure.
